INSPIRATION AND EXPERIENCES FROM THE JOINT ANALYSIS OF SHINING EXAMPLES OF COMPREHENSIVE ENERGY RENOVATION BUILDING PROJECTS WITHIN IEA EBC ANNEX 56

Webinar: Renovating Buildings with Cost-Effective Reductions in Energy and Carbon Emissions - Findings from IEA EBC Annex 56

Ca'S. Orsola, Treviso, Italy

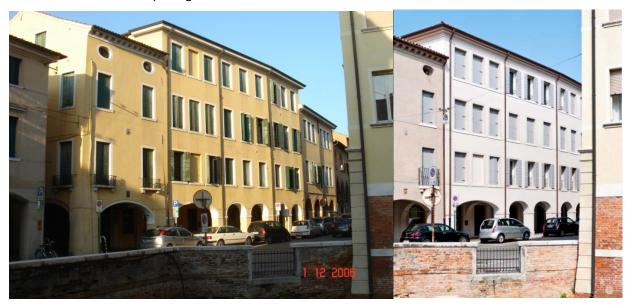
General view of the building before and after the intervention

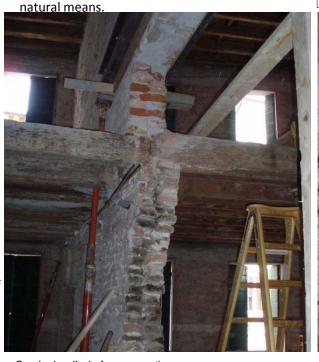
Crooked walls, before renovation

The construction system was based on bearing masonry with covered solid bricks. The floor had a wooden structure, while the ground floor leaned directly on soil. The roof is made of hollow tiles sheets with a wooden structure and a lightweight ceiling slab. The windows frames were made of wood and the windows used to have a single glass. There is no insulation in the external walls, roof and floors.

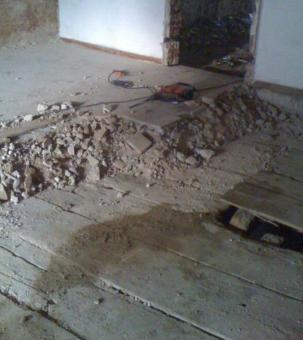
Demolished partition walls left and used as a substrate

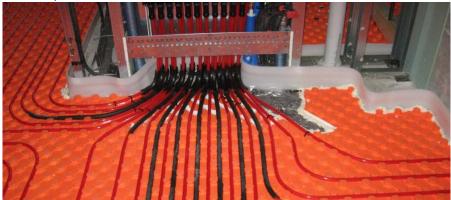
Radiant system

The HVAC generation system is a water to water centralized heat pump/chiller. The underlying well is the hot/cold water source and internal comfort is achieved exploiting a radiant system installed in the floor together with a dehumidification system for the summer period.

- Heating and Cooling: 32 kW heat pump and distribution with radiant floor system;
- DHW: 20 kW heat pump;
- Ventilation: mechanical ventilation system with heat recovery box with 95% efficiency.

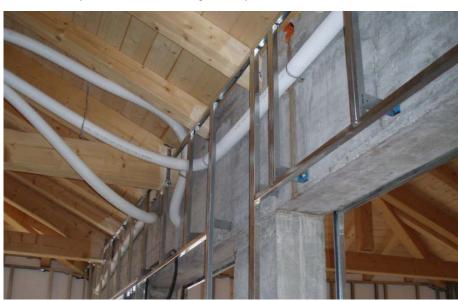
Mechanical ventilation system
